CHARACTERIZATION AND ANALYSIS OF THE CALICHE WALLS OF
THE GREAT HOUSE, CASA GRANDE RUINS NATIONAL
MONUMENT, COOLIDGE, ARIZONA

ELISA MARIA DEL BONO

A THESIS

1999

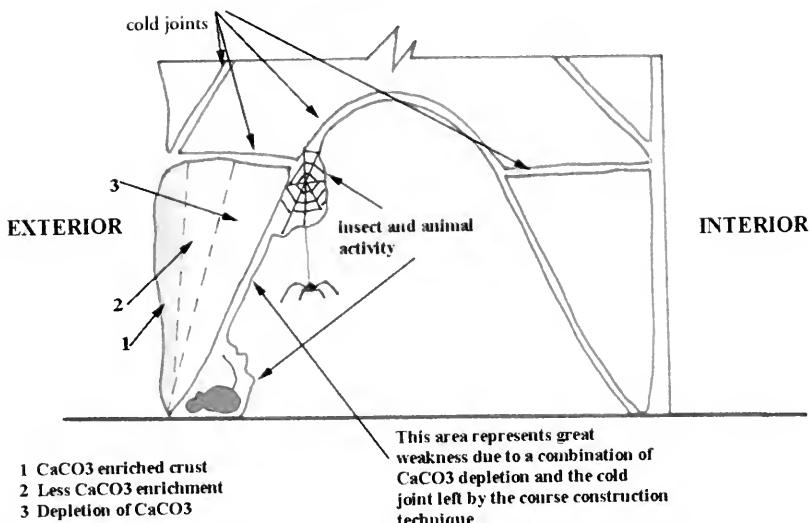
DETACHMENT OF FRAGMENTS

course construction technique, (2) the friability of the material due to calcium carbonate impoverishment along the plane of contact of an internal cold joint, and (3) a combination of nature-related processes of deterioration (figure 76).

Detachment of fragments is mainly caused by a combination of internal cold joints (construction technique), movement of CaCO₃ (weathering), and various nature-related causes of deterioration

Figure 76: Course wall cross section showing different vulnerabilities of the course to deterioration

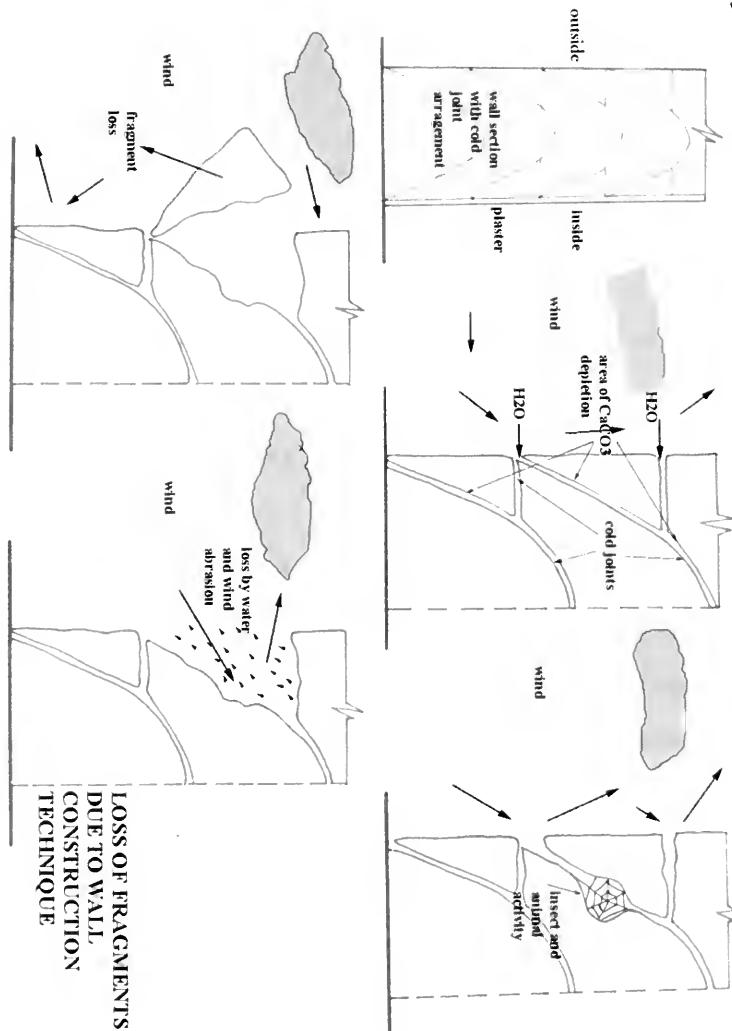
Figure 77: Loss of wall fragments

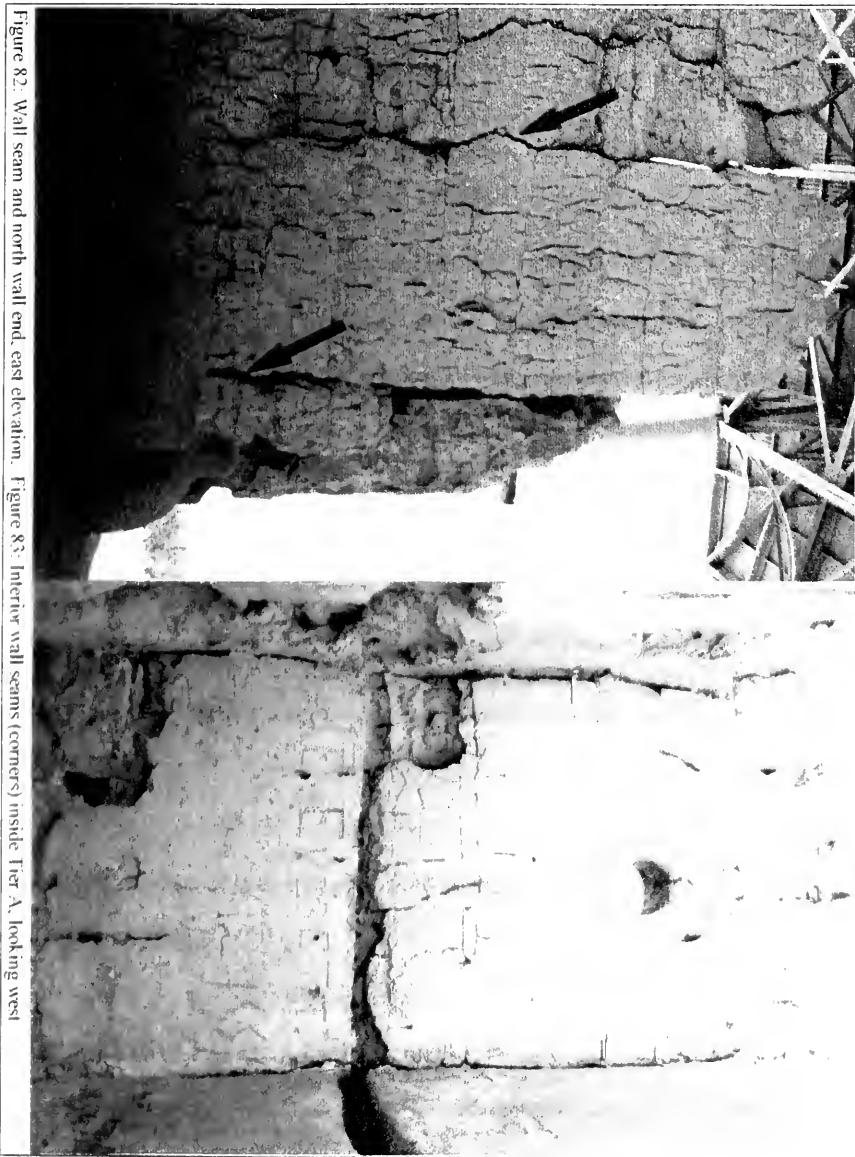
Figure 82. Wall seam and north wall end, east elevation. Figure 83. Interior wall seams (corners) inside Tier A, looking west

elevation seem to represent what is left from wall seams.
